**Federal Transit  
Administration**

## **Standardization of Availability Location, and Use of Safety Equipment on Urban Transit Buses**

Final Report  
May 1996

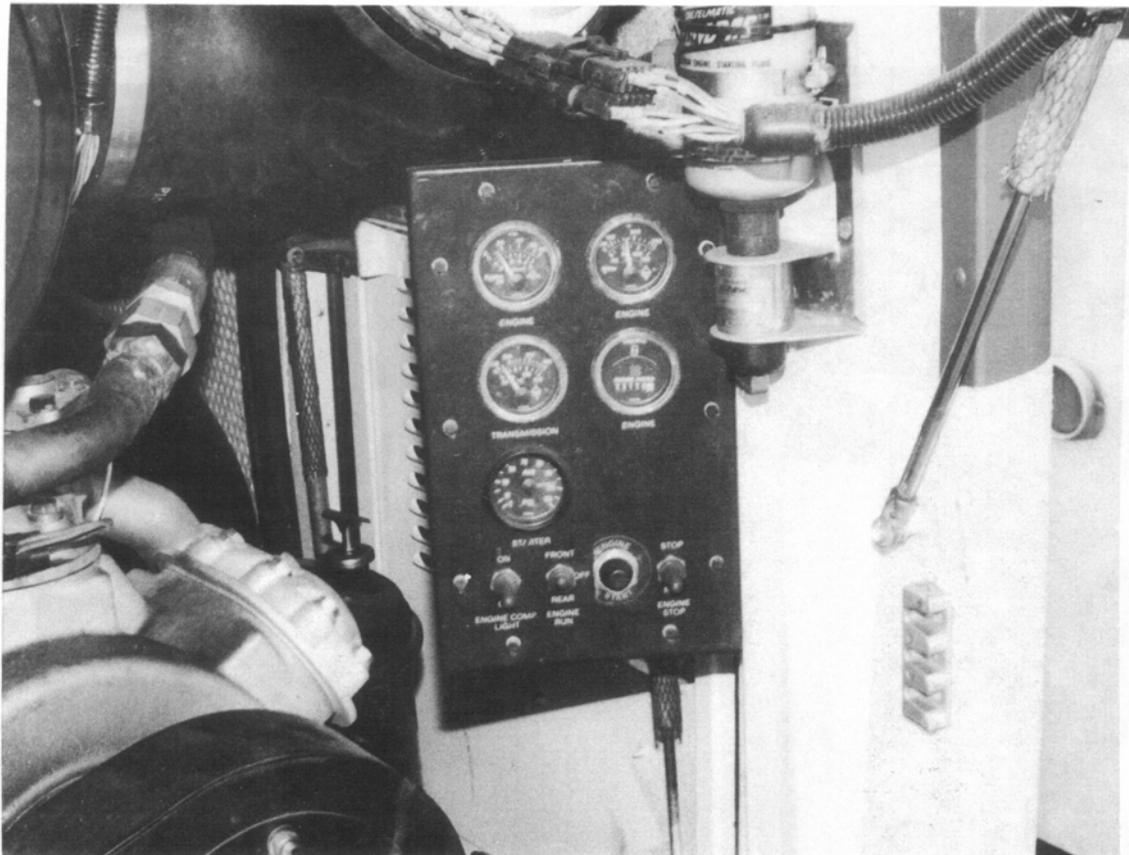
**PHOTOGRAPH 2-13  
IKARUS USA ARTICULATED MODEL:  
ENGINE COMPARTMENT CONTROL BOX  
CONTAINING ENGINE STOP SWITCH**

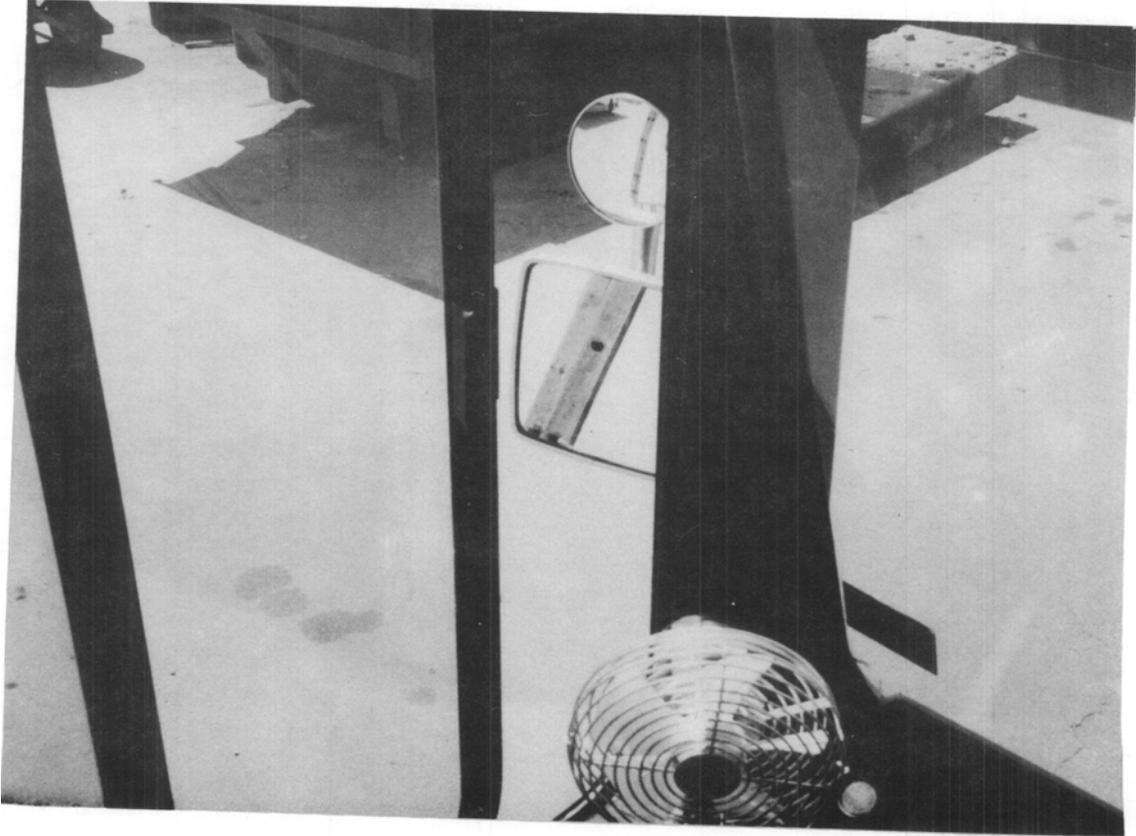
**PHOTOGRAPH 2-29  
GILLIG PHANTOM MODEL:  
FORWARD SLIDING DRIVER'S WINDOW PARTIALLY OPENED  
LIMITED INGRESS**

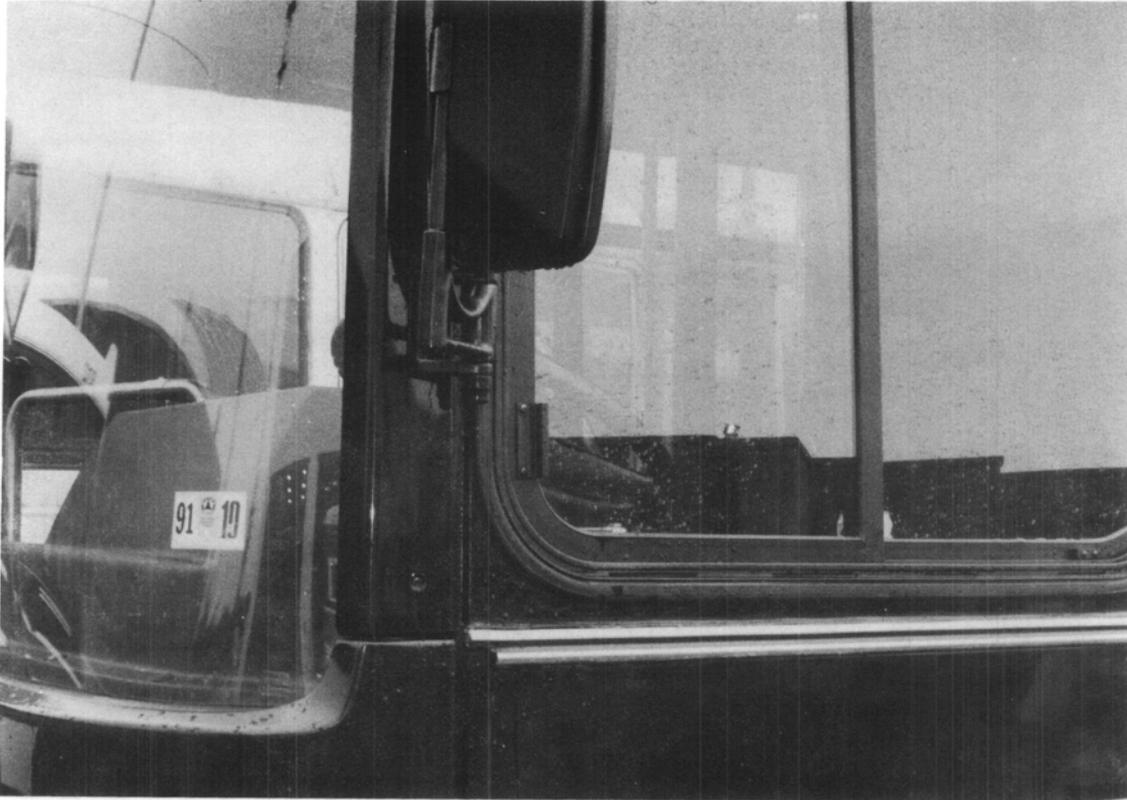
**PHOTOGRAPH 2-30  
IKARUS USA ARTICULATED MODEL:  
DRIVER'S SIDE WINDOW — LIMITED INGRESS**

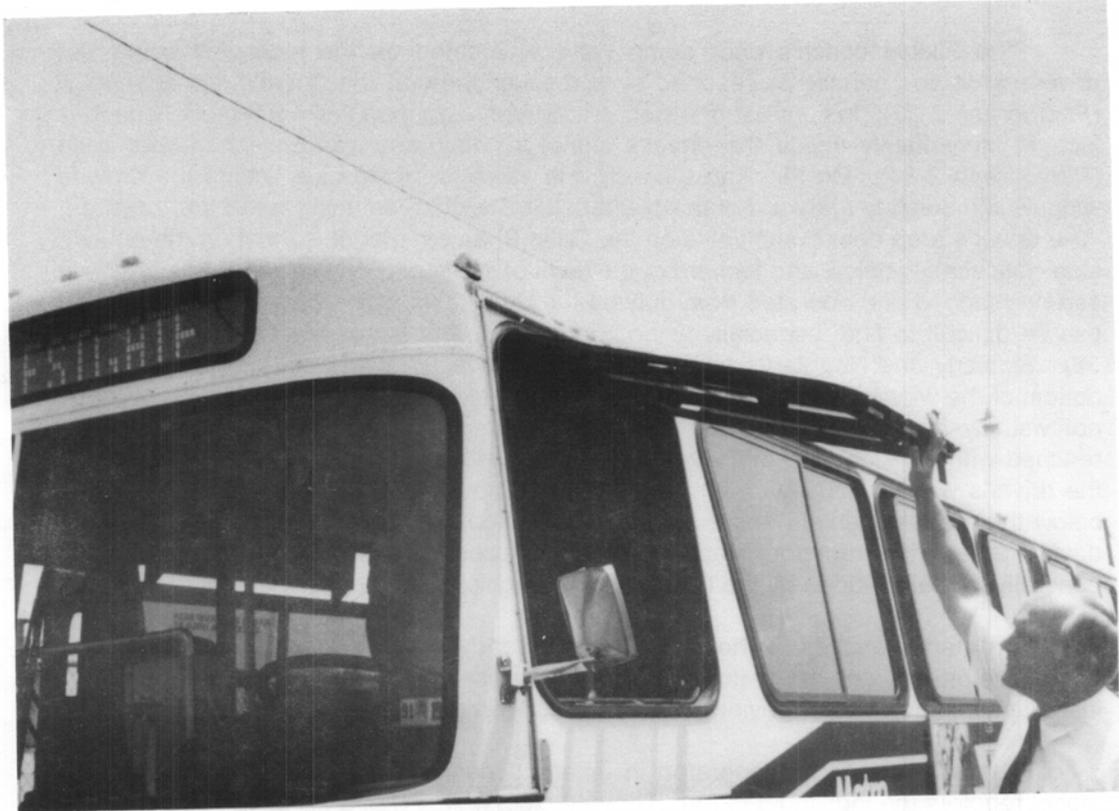
**PHOTOGRAPH 2-32  
ORION MODEL:  
DRIVER'S WINDOWS AS INGRESS**

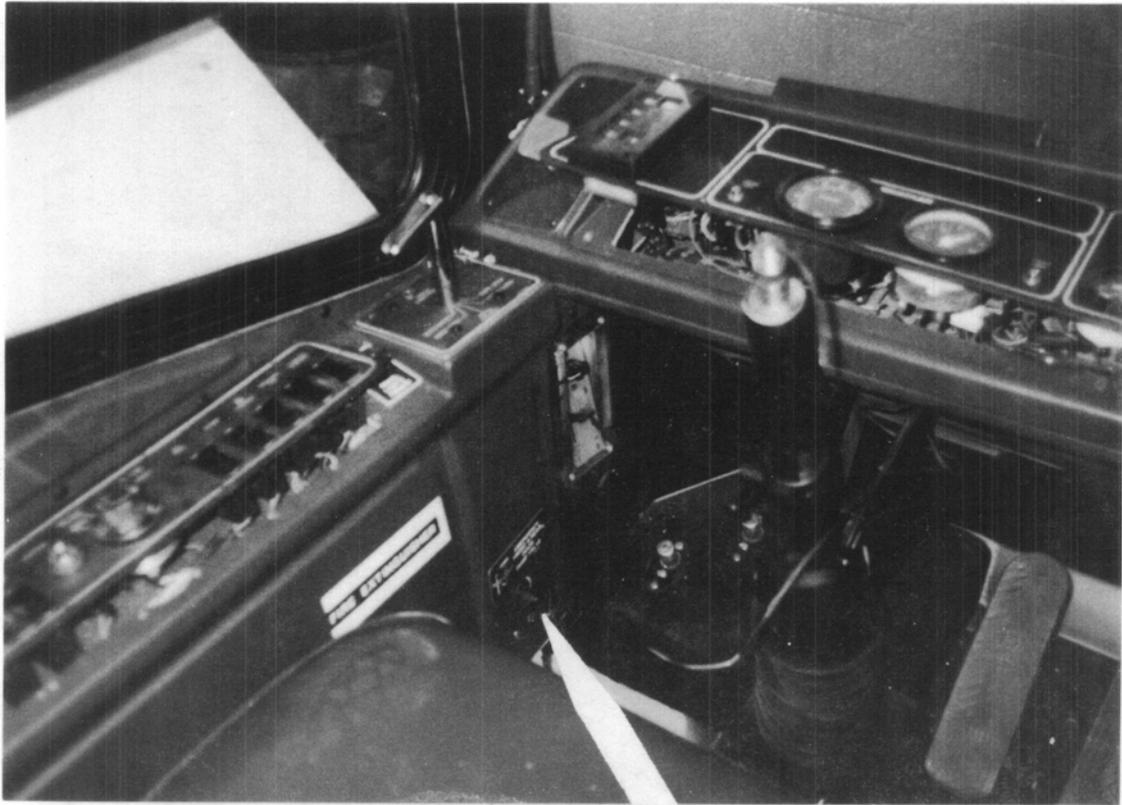
**PHOTOGRAPH 2-37  
NEOPLAN USA MODEL:  
LOCATION OF DRIVER'S AREA DOOR DUMP VALVE  
BELOW DOOR CONTROL HANDLE**

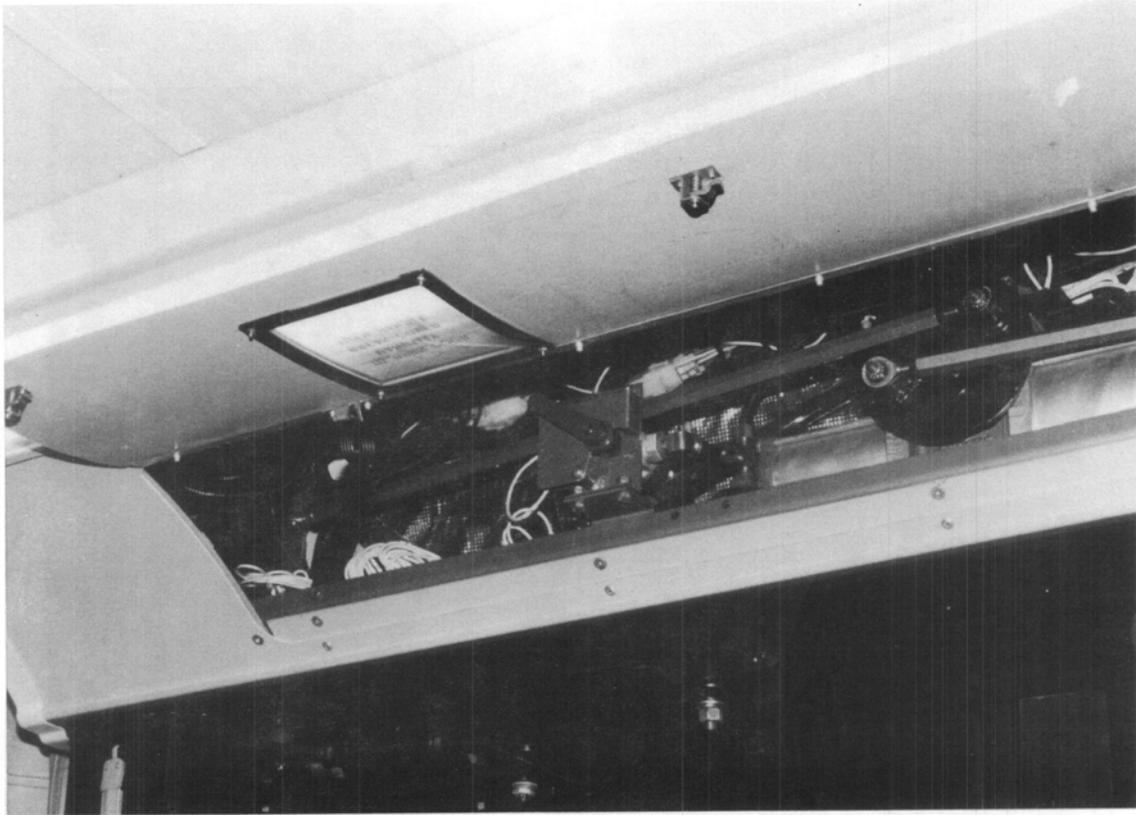
**PHOTOGRAPH 2-47**  
**IKARUS USA ARTICULATED MODEL:**  
**LOCATION OF REAR DOOR DUMP VALVE OVER REAR DOORS**

In all six model coaches, if for whatever reason a door is already open and the door valve is dumped or the switch activated, the door may close and could cause injuries. The summary of information and pictures of this safety device on the six bus models are shown in *Table 2-9* and *Photographs 2-44* through *2-50*.

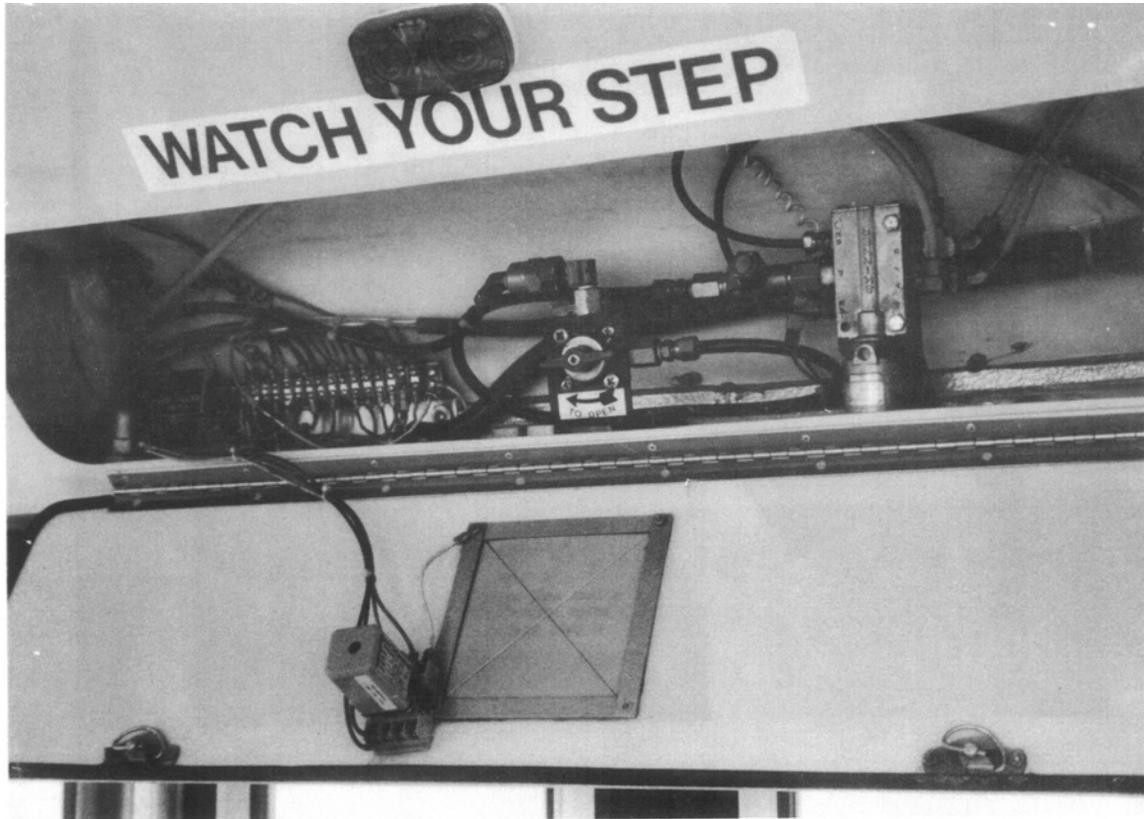
**PHOTOGRAPH 2-50  
ORION MODEL:  
EMERGENCY REAR DOOR DUMP VALVE**

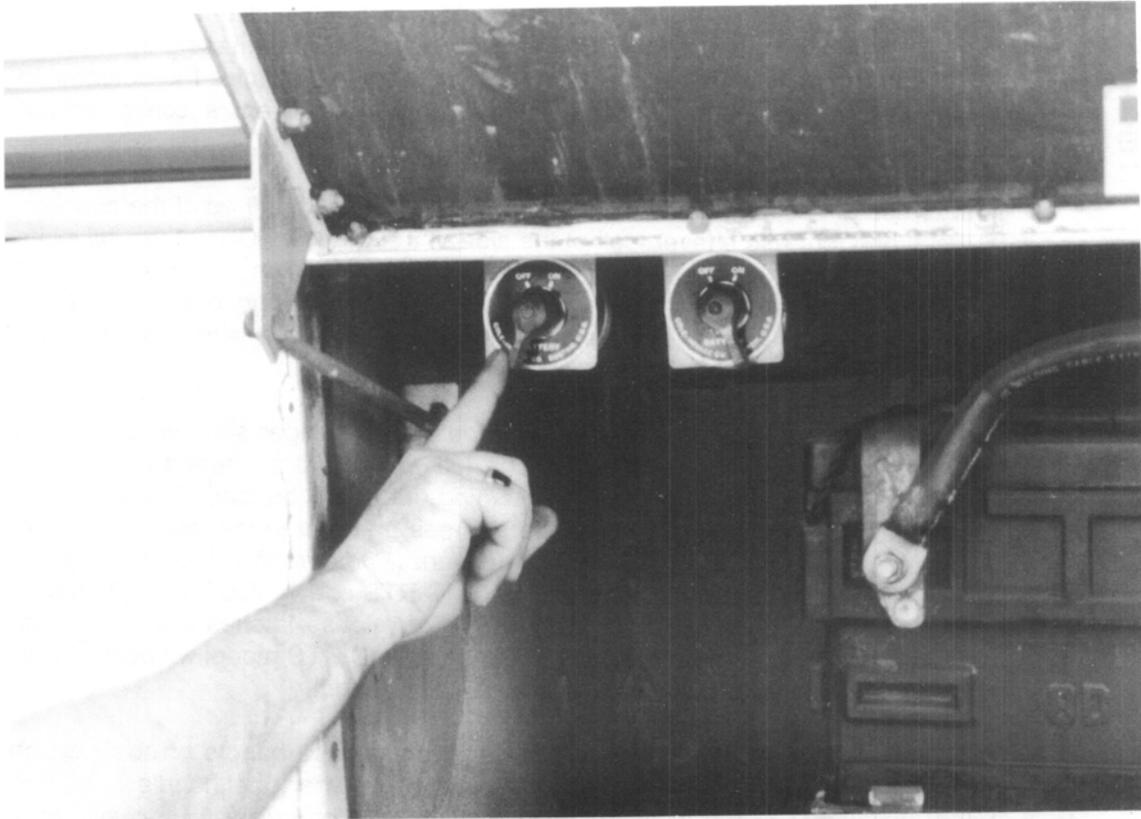
**PHOTOGRAPH 2-57**  
**ORION MODEL:**  
**LOCATION OF ELECTRICAL (BATTERY) SWITCHES**

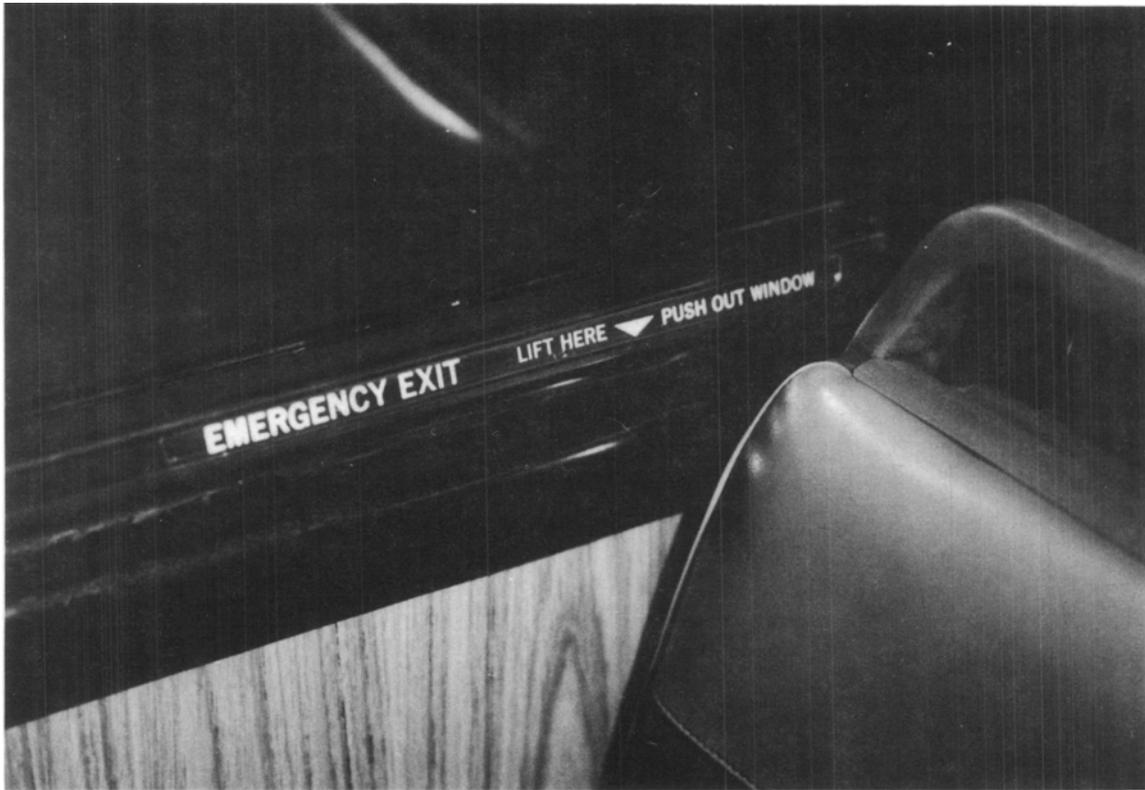
**PHOTOGRAPH 2-58  
FLXIBLE MODEL:  
EMERGENCY RELEASE FOR FULL PASSENGER SIDE WINDOW (INTERIOR)**

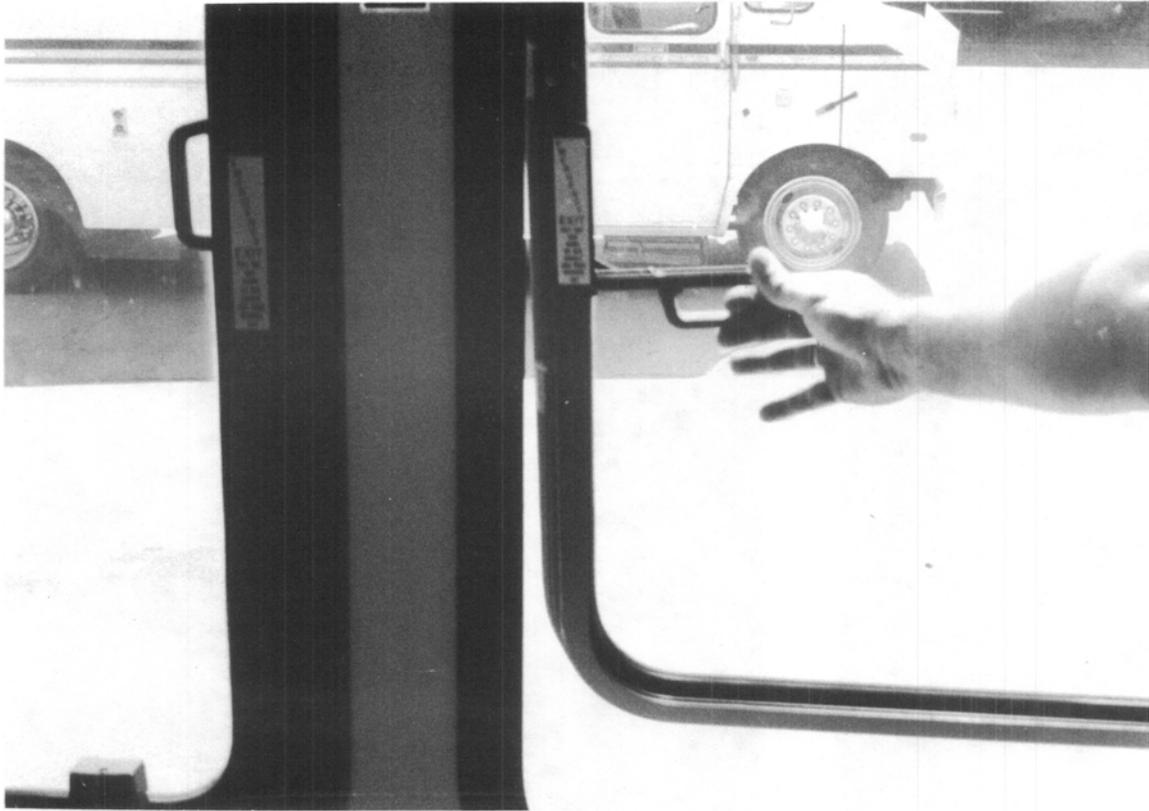
**PHOTOGRAPH 2-61**  
**GILLIG PHANTOM MODEL:**  
**USE OF EMERGENCY RELEASE FOR EMERGENCY PASSENGER SIDE WINDOW**

The Gillig, Ikarus, and Orion models have a red release handle on the side of the window which releases the window latches in the sill when the handle is pulled down toward the center of the window (*Photographs 2-61 through 2-67*). While this handle is held down the window can be pushed outward at the bottom. Because the release handles are on the side and the locks are actually in the bottom sill, a mechanical arrangement of cable and springs allows the handle to release the latches (*Photograph 2-63*) only if they are lubricated, regularly cycled and maintained to prevent rusting and breakage. There is some variation as to whether the handle is located on the forward or rear side of the glazing and how many windows are so equipped. The Orion model coach has only one emergency exit passenger window.

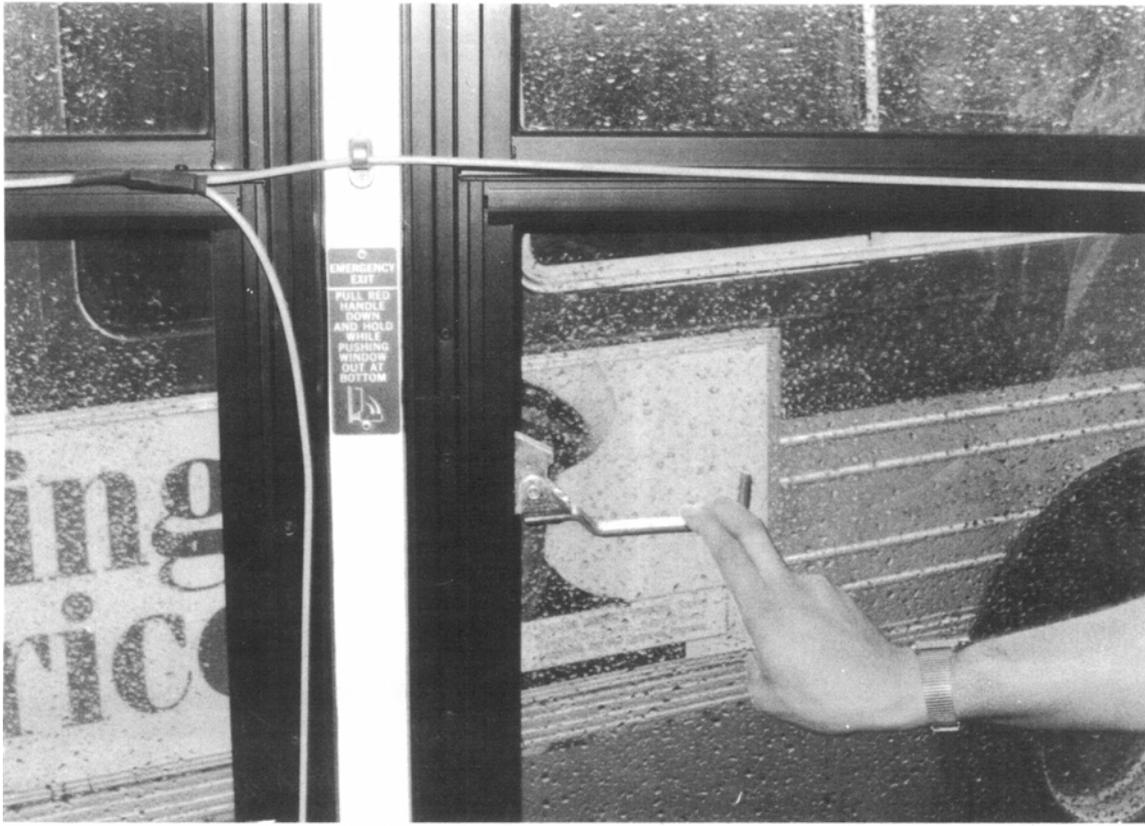
**PHOTOGRAPH 2-62**  
**IKARUS USA ARTICULATED MODEL:**  
**USE OF EMERGENCY RELEASE FOR EMERGENCY PASSENGER SIDE WINDOW**

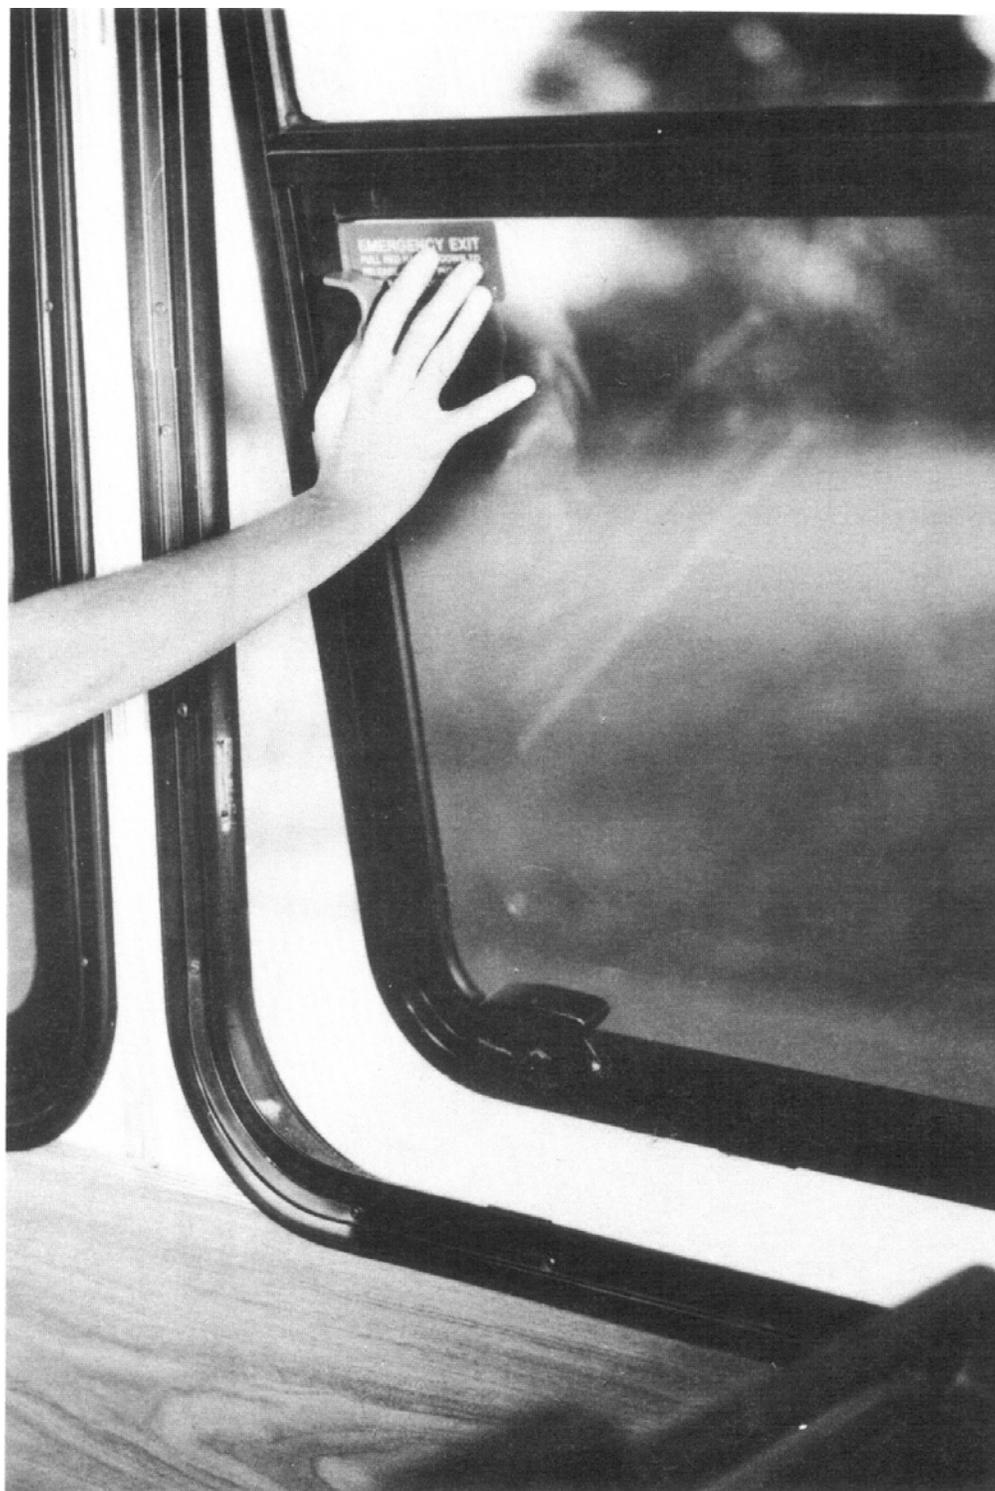
**PHOTOGRAPH 2-64  
NEOPLAN USA MODEL:  
USE OF EMERGENCY PASSENGER SIDE WINDOW**

example, requires a rescuer on each side of the window on a ladder and a fair amount of rocking back and forth of the window to cause the window to be released. The weight of typical passenger side windows makes this a dangerous undertaking. It seems reasonable that a window design with hinges at the top and with an automatic prop to hold it open would be a better design.

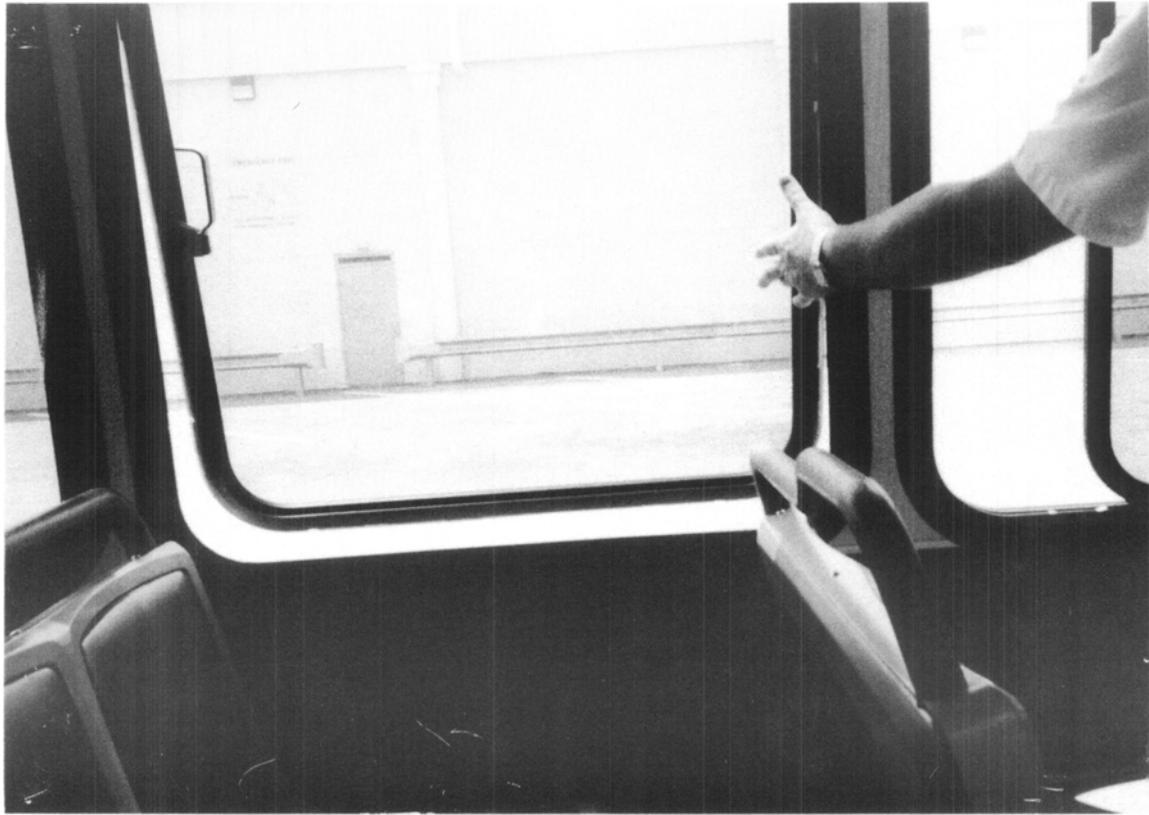
**PHOTOGRAPH 2-67  
ORION MODEL:  
SINGLE EMERGENCY PASSENGER SIDE WINDOW**
